**American
Building
Consultants, inc.**
Residential/Commercial Inspections

INSPECTION REPORT

0 Night St. Norfolk MA

THE PROPERTY INSPECTED: Single Family House
Colonial Style
Wood Framing

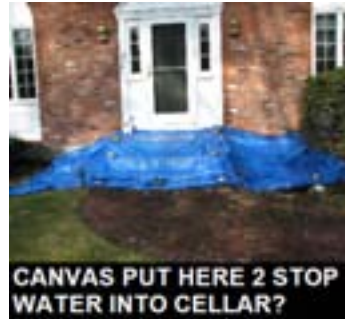
FRONT STEPS

- The steps were constructed with brick.

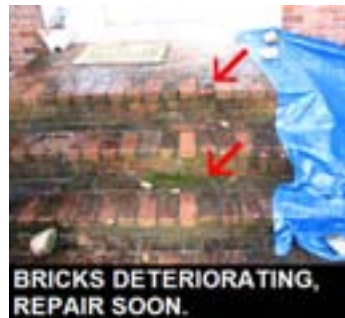
STEPS OBSERVATIONS:

- Handrails are missing. Add for comfort/safety at this time. Required when there are 3 steps or more/ there is more than 30 inches from the top of the stairs to the ground.
- There are damaged stair treads. A tripping hazard. Repair now.
- Wear/tear/deterioration visible. Repair now.

MASON: Have a mason evaluate the noted deficiencies and "repair/replace" as needed at this time.

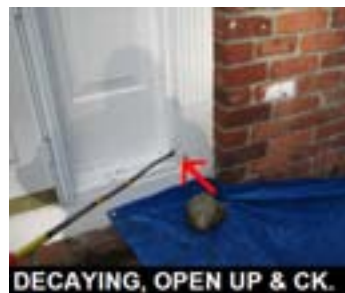
DOOR OBSERVATIONS:

- The doorbell worked..
- Wood decay visible. Repair now.

CARPENTER: Have a carpenter evaluate the noted "deficiencies" and "repair/replace" as needed at this time.

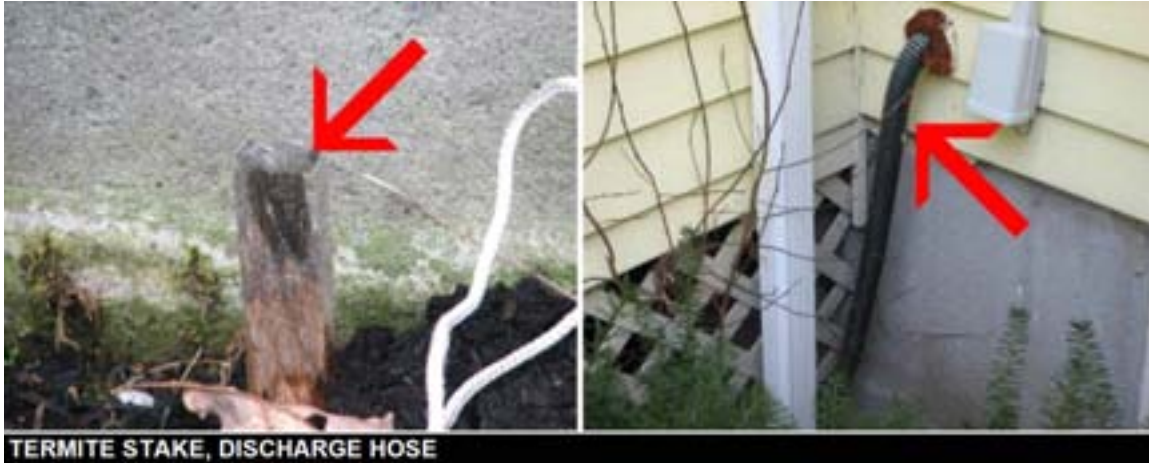
FOUNDATION OBSERVATION:

- There was discharge drain line exiting the foundation. It maybe from a sump pump system. **Wood stakes** around foundation perimeter used by pest control companies when a termite problem exists. Ask the owner about this now. Get paperwork, check with the company, now.

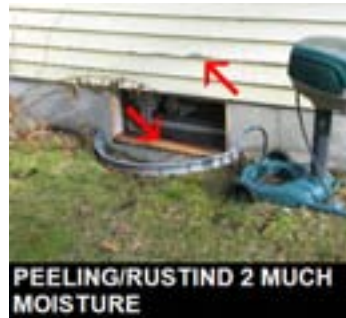
WINDOW OBSERVATION:

- Deteriorating window frames. Repair now.
- **Window wells** visible. Make sure there is proper drainage in the bottom. Crushed stone is a good material to use.
- **Cover window wells** with a plastic cover to help keep out water, leaves/snow help "conserve energy."
- **Storm windows** not visible. Add were missing to help "conserve energy."

PAINTER: Have a painter evaluate the "noted deficiencies" and repair as needed at this time.

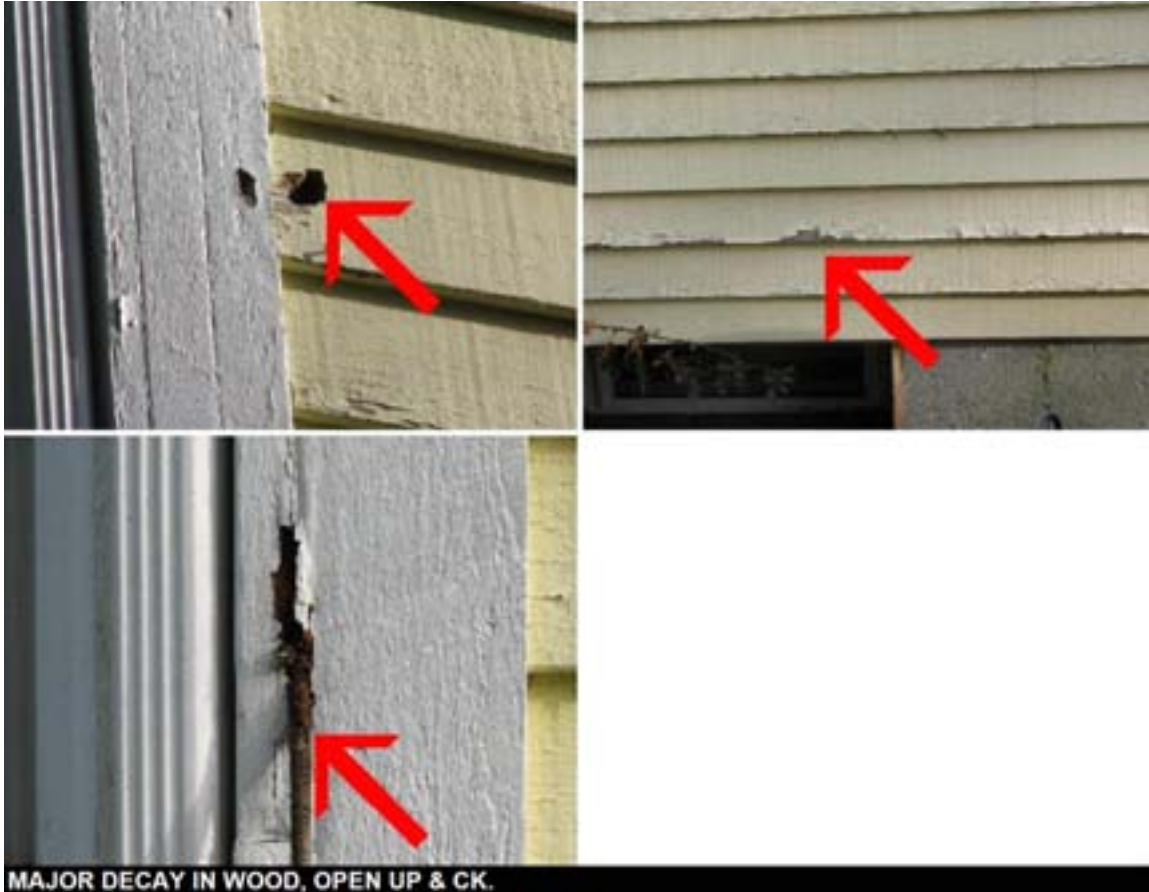
SIDING OBSERVATIONS: 1

- Wood decay visible in spots. Repair soon.
- Deterioration visible in spots. Repair soon.
- Peeling paint visible. Repair soon.
- The wood has recently been painted. Painted areas can cover up defects, if any, for six months to a year.

- Small holes from birds/insects looking for food or nesting visible. Something wrong in the wood. Repair now.

CARPENTER: Have a carpenter evaluate the noted deficiencies & repair/replace as needed at this time.

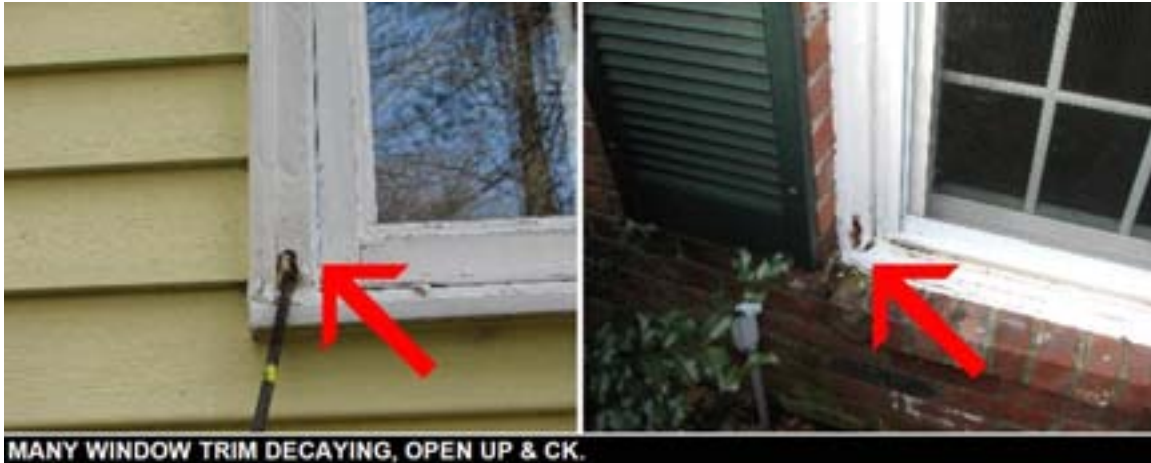
WINDOW OBSERVATIONS:

- The trim around the windows is wood. Keep painted/maintained.
- Wood decay visible in spots. Repair soon.
- Windows have been painted recently which can cover up defects, if any, for six months to a year.

CARPENTER: Have a carpenter evaluate the noted "deficiencies" and "repair/replace" as needed at this time.

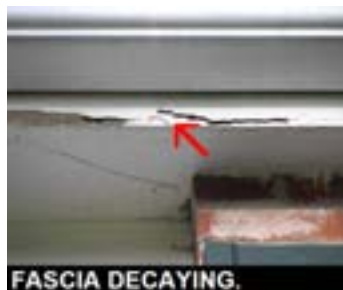
FASCIA OBSERVATIONS:

- Soffit vents were missing at the eaves. They help ventilate the roof/reduce ice dam build-up. Add now.
- There is wood decay. Repair now.

CARPENTER: Have a carpenter evaluate the noted "deficiencies" and "repair/replace" as needed at this time.

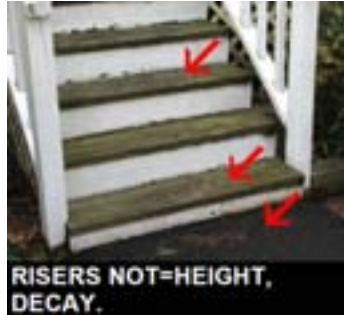
STEPS OBSERVATIONS:

- Railings inplace for comfort/safety. Monitor/maintain.
- The stair risers weren't = height. They shouldn't be more than 7 inches in height. This can be a tripping hazard.

CARPENTER: Have a carpenter evaluate the noted "deficiencies" & "repair/replace" as needed now.

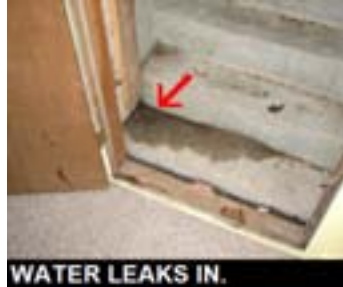
ENTRY OBSERVATIONS 1:

- There is an interior door at the bottom of the stairs.
- Water present. Remedial action is necessary now.

HANDYMAN: Have a handy person evaluate the "deficiencies" noted & "repair/replace" as needed at this time.

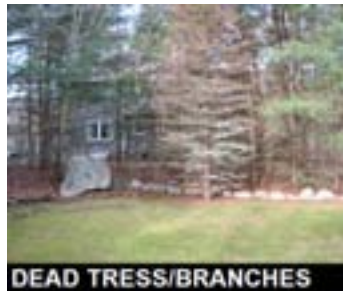
LANDSCAPE OBSERVATIONS:

- Dead branches visible. Remove now
- The landscaping is well maintained. Continue this practice.

TREE SURGEON: Have a tree surgeon evaluate noted deficiencies/ remove branches as needed at this time.

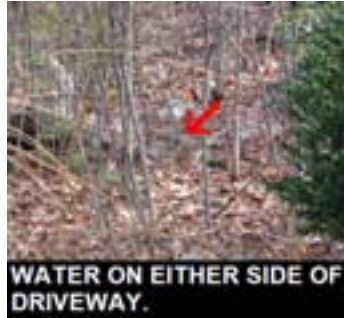
GRADING OBSERVATIONS:

- Regrade the low areas next to the foundation so that water will pitch away from it, soon.
- There is a low, wet area at rear of the property. Ask the owner about any problems with this area.

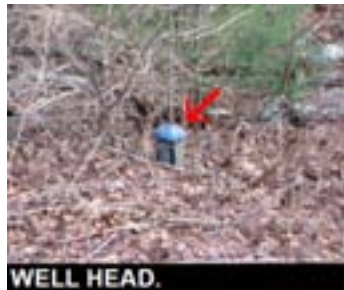
WELL HEAD OBSERVATIONS:

- Wellhead visible in yard. Ask the owner about any present/past problems, now.

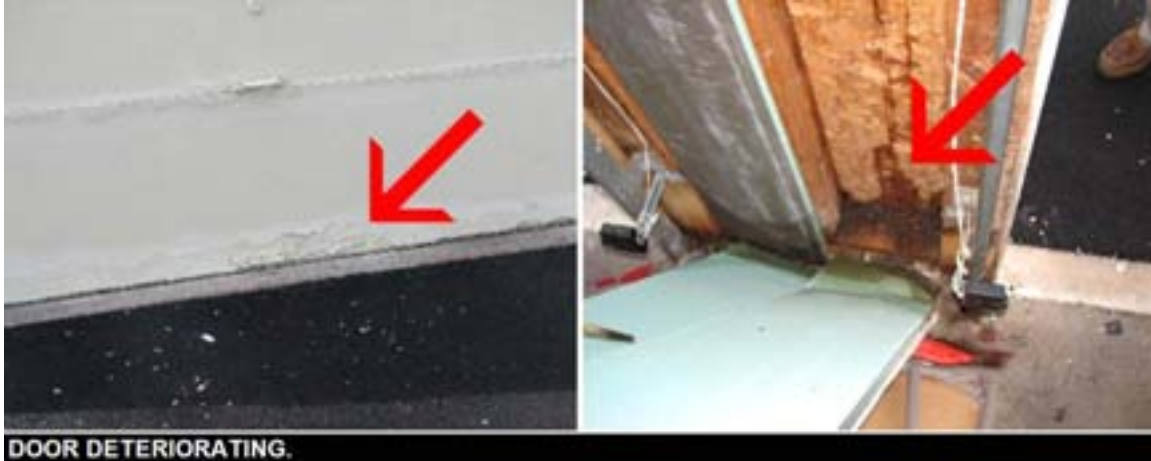
DOORS OBSERVATIONS:

- The automatic door opener in the downward mode, stopped & reversed itself when a light barrier was placed in its' path.
- The automatic door didn't reverse itself when it hit a barrier as required. Repair now.
- The photoelectric eyes worked, as required, when a barrier was placed between them
- **Wood decay visible. Repair now.**

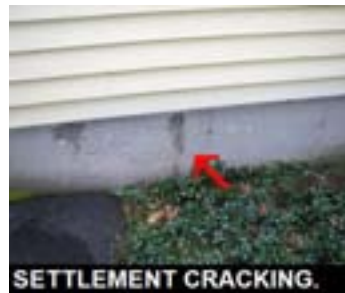
FOUNDATION OBSERVATION:

- **Settlement cracks visible. Foundation movement has occurred. Repair now.**
- The downspouts drains into the ground next to this area.

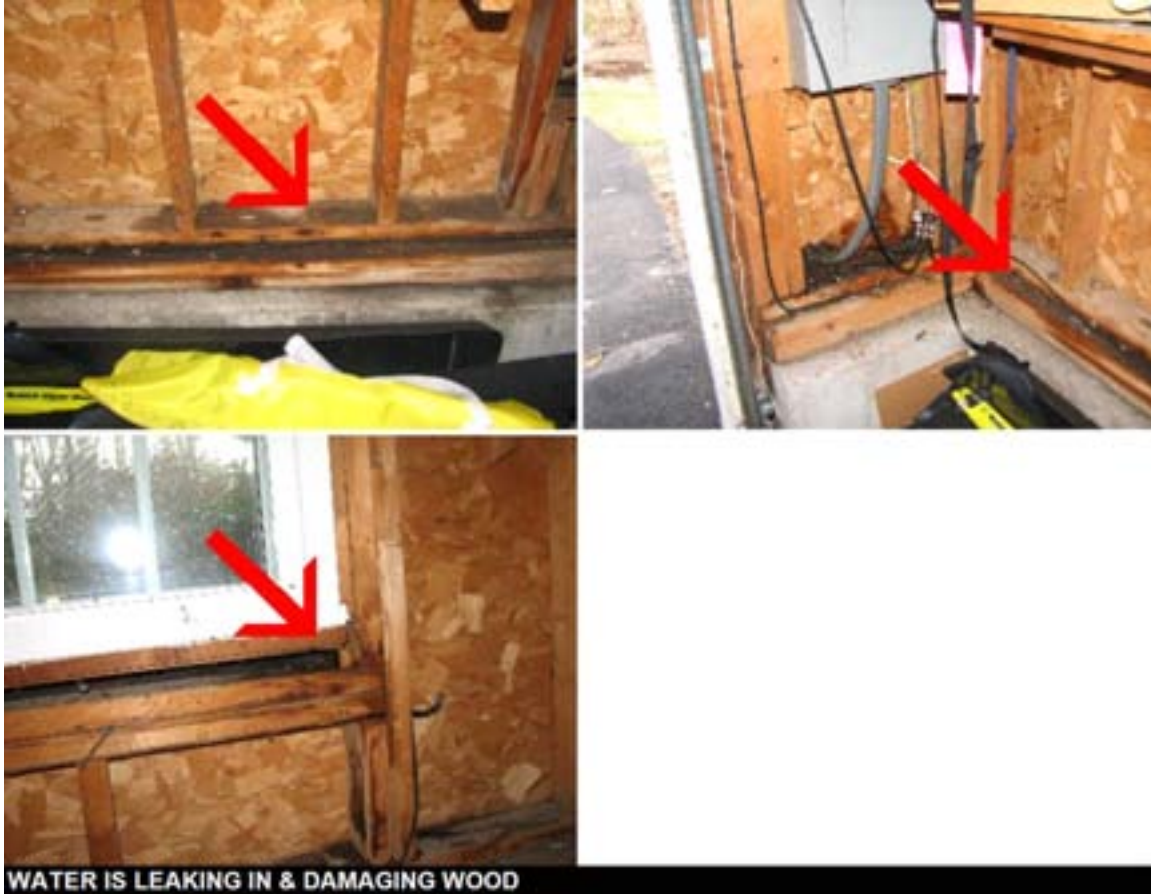
WALL OBSERVATIONS:

- There is water staining. Repair now.

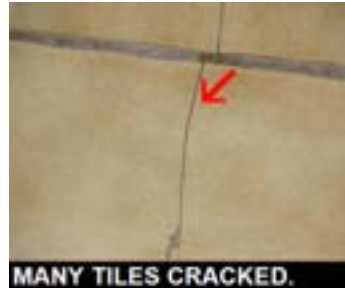
FLOOR OBSERVATIONS:

- There is cracking.

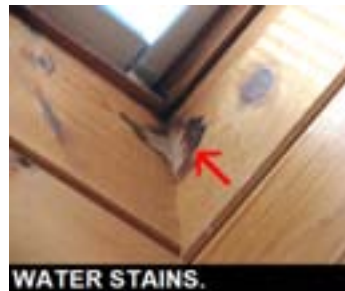
CEILING OBSERVATIONS:

- There were skylights. Ask the owner if there have been any problems.
- The inspector observed "water stains" around the interior of the skylight. Ask the owners about this.

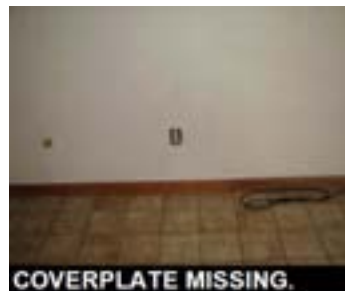
OUTLET OBSERVATIONS:

- The tested outlet was grounded" properly.
- Cover plates were missing from outlets/switches. These protect from hot wires. This is a hazard. Add now.

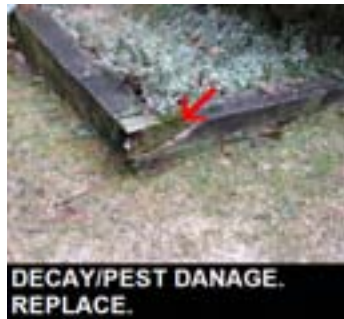
FENCE/WALL OBSERVATIONS:

- Wood decay visible. Repair soon.

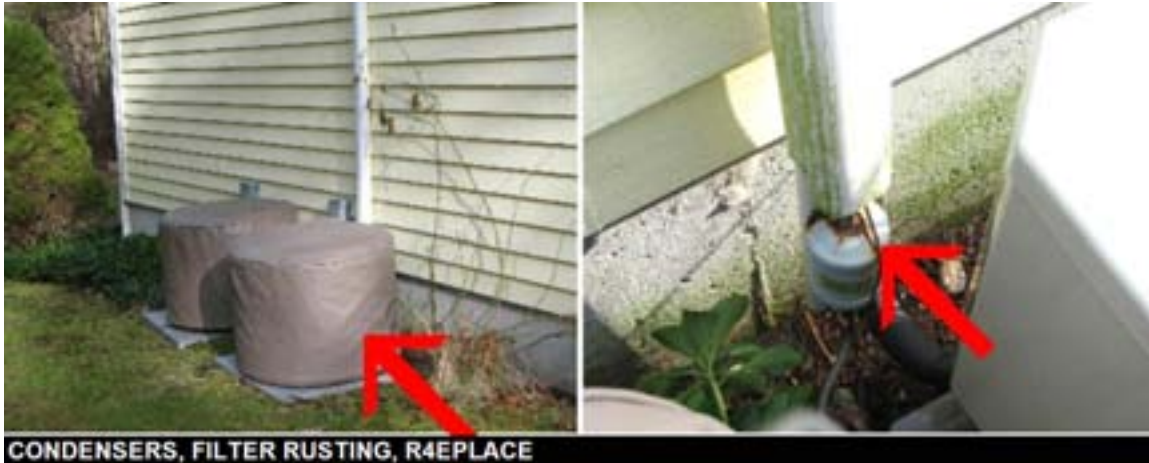
LOCATION:

- The condenser is at the left side.
- There is more than one AC condensers inplace.

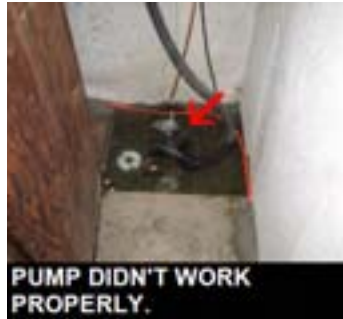
DAMPNESS/WATER/MOLD/MILDEW:

- Ask the owner if there has any been dampness/moisture/water problems now.
- Water visible. Ask the owner about this now. Repair now.
- Too much moisture/dampness in the air. Add a de-humidifier & ask owner about this now.

- There is sump pit in place. We do not know how well it works. Usually used for water problems. Ask the owner about this now. A sump pump visible. We don't know how well it works. Get a battery back-up system in case the power goes out. Ask owner about how well it works, now.
The inspector is forbidden to turn it on.
The pit is open. Add a cover to reduce the amount of moisture in the air & allow radon escape. Put a removable cover on now.

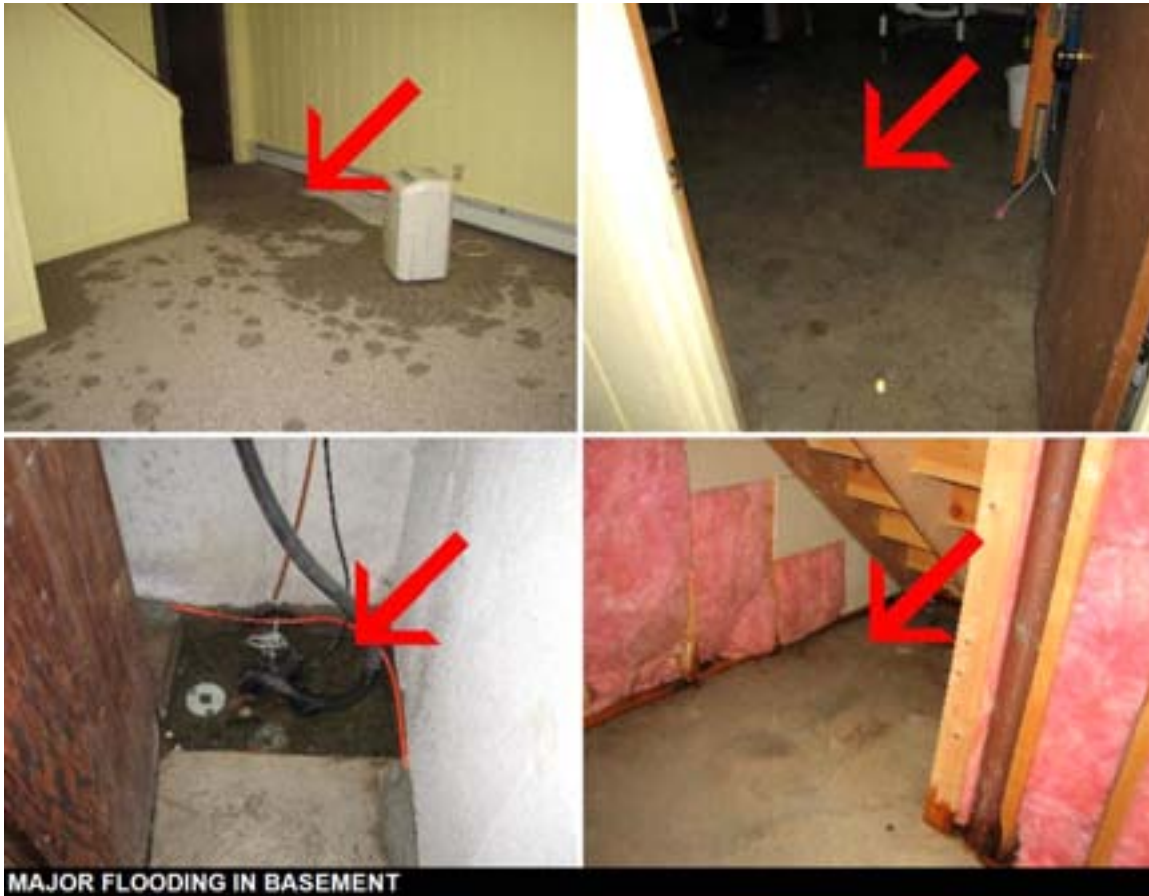
FLOOR OBSERVATIONS:

- Personal effects blocked views. Remove effects & inspect now.
- **Water visible.** Ask owner about this. How much comes in? How often? Some of the remedies for this problem are: regrade the area around the exterior foundation away from the property, redirect downspouts.
- Add a sump pit/pump and/or add a perimeter drainage system in the basement.

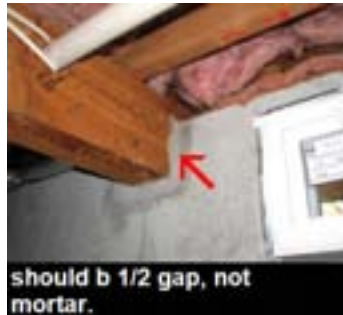
BEAM OBSERVATIONS:

- **H**orizontal "checking" visible. Common in older beams & usually not a problem. Monitor.
- **T**he is mortar around the beam in the beam pocket instead of a 1/2 inch air space around the beam as required. Remove mortar.

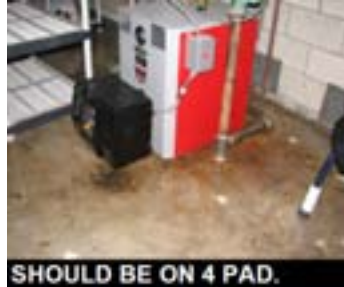
SYSTEM TYPE:

- The heating system was "forced hot water", that is water circulates through pipes to radiators.
- The heating unit was constructed mainly of cast iron. These have an average life of approximately 30-50 years.
- **Make sure there are proper permits for all systems.**

It's a good building practice for the heating equipment to rest on a 4 inch concrete pad.

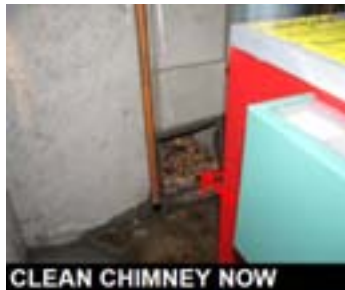
- This allows the barometric damper to get locked into one position, open. This can allow soot/carbon monoxide escape. This is a hazard.
- There fire stopping between the chimney and the ceiling. This helps stop the spread of fire up into the structure.

CHIMNEY SWEEP: Have a chimney sweep evaluate the "deficiencies" noted and repair/replace as needed at this time.

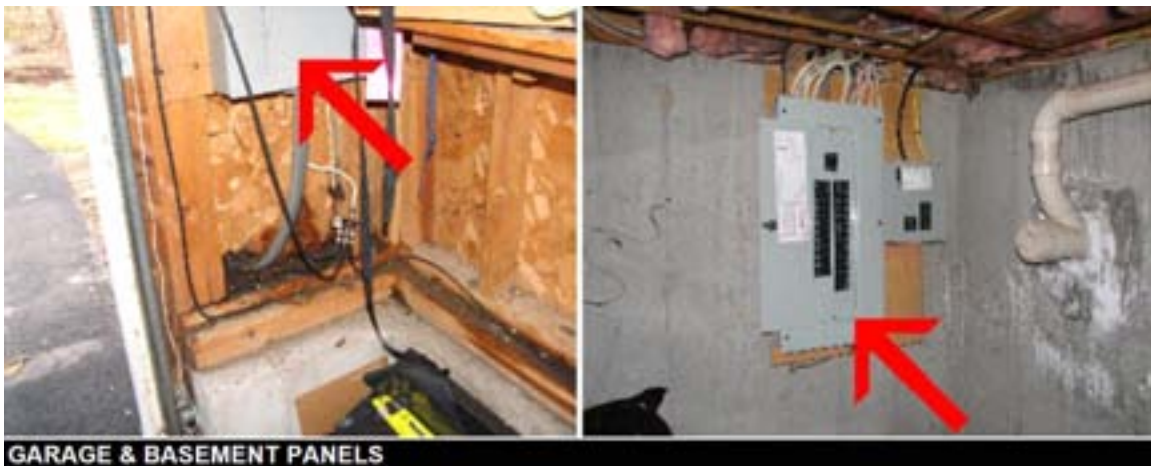
ESTIMATED DISCONNECT VOLTAGE/PHASE/WIRING:

120/240 volt, (single phase), [three wire]

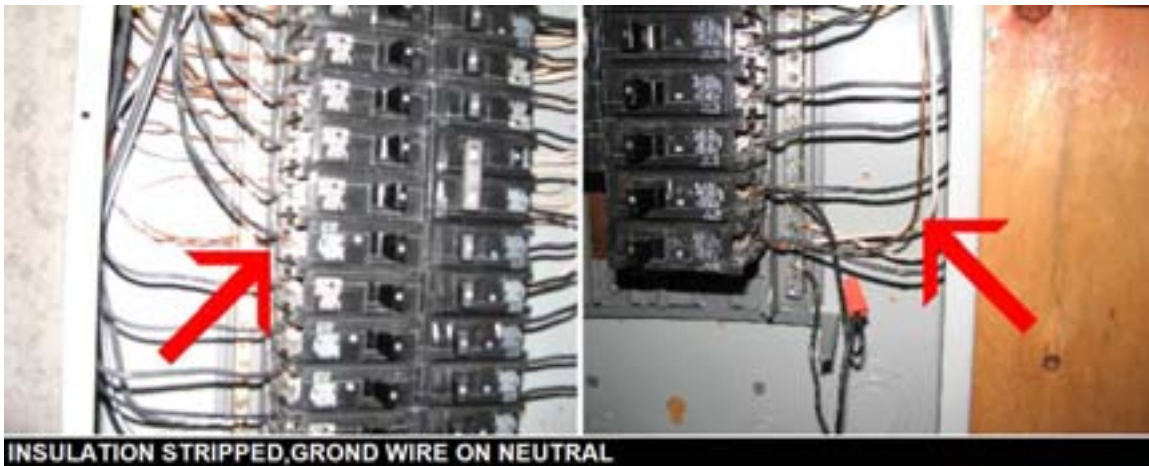
PANEL WIRING OBSERVATIONS 1:

- Wiring insulation is stripped too high up the wires. Insulation should be flush with the terminal. A hazard. Repair now.
- There was a coper ground wire on the neutral bar instead of the grounding bar. Switch it over.

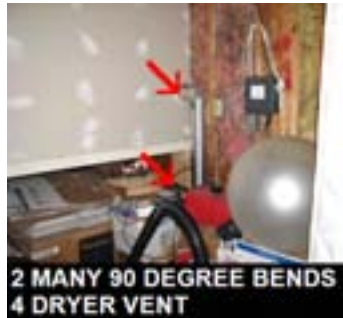
APPLIANCES/FUEL/VENTING:

- The laundry is located in the living space. laundry room. There is a washing machine in place. Ask the owner about how well it works now.
- There is an electric dryer in place. Ask the owner about how well it works now.
- The dryer vent duct is too long. Moisture/lint can collect in it. Duct shouldn't be more than 8 feet in length. Repair now.
- There are 2 many "kinks/loopes" in the vent duct. Lint/moisture can collect. This is a hazard. Repair now.
- There isn't a drip pan under the washing machine in case leaks. Add a drain pan & an alarm to signal if there is a water leak.

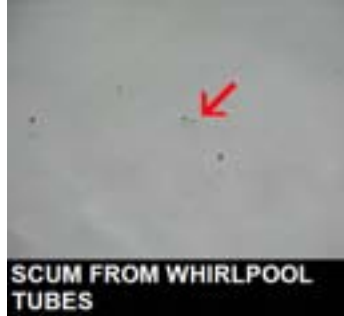
TUB/SHOWER OBSERVATIONS:

- The water stop worked.
- There is a "whirl pool" type tub in place. There is an access door to the motor. When the whirl pool started pumping water, a "dirty scum" type of material appeared. Sterilize before using.

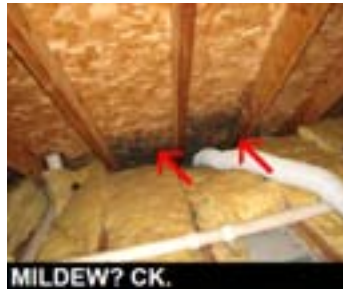
OBSERVATIONS:

- Mold/mildew visible. 2 much moisture present. Add more ventilation/clean these areas with bleach in water. Take samples, send to lab now.

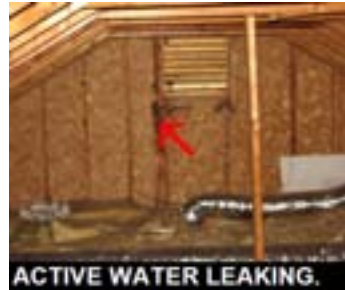
WATER STAINS::

- Active water staining/wet areas. Repair now.

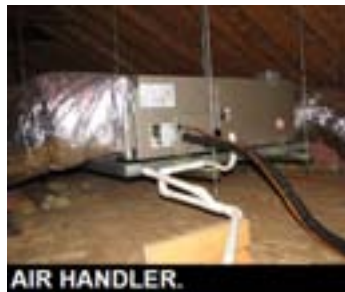
AC AIR HANDLER:**LOCATION:**

The AC air handler in the attic.
